INDOOR AIR QUALITY ASSESSMENT

**Barrows at Wood End Elementary School
85 Sunset Rock Lane
Reading, Massachusetts**

Prepared by:
Massachusetts Department of Public Health
Center for Environmental Health
Bureau of Environmental Health Assessment
Emergency Response/Indoor Air Quality Program
December 2004

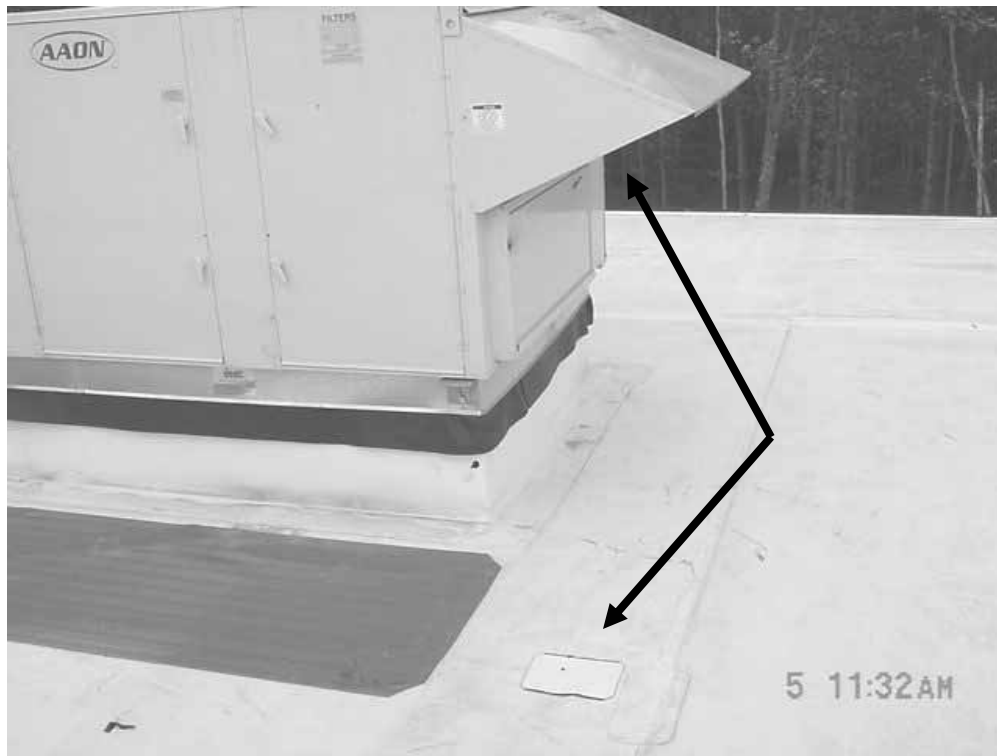
Picture 1

On Tuesday October 26, 2004 a number of students and staff became sick as a result of odor infiltration from roofing materials (i.e., solvents and adhesive). According to school officials, roofing contractors were patching several areas on the roof during school hours. Due to the close proximity of the roofing work to rooftop air handling equipment (Picture 1), odors from materials were entrained (drawn) into the ventilation system. The Reading Fire

Roof Patch in Close Proximity to Rooftop Air Handling Unit Air Intake

1. Continue to work with the roofing contractor to schedule roof repairs during unoccupied periods. Ensure that outside contractors check in with school maintenance personnel before conducting repairs/activities that create odors, dusts fumes, etc.
2. Use local exhaust ventilation and isolation techniques to control for renovation pollutants (i.e., deactivation and sealing of AHUs).
3. Continue working with HVAC contractor to troubleshoot problems and develop a preventive maintenance plan prior to turnover of ownership of mechanical ventilation system and components.
4. Change filters for air-handling equipment as per manufacturer's instructions or more frequently if needed. Ensure filters fit flush in their racks with no spaces to prevent bypass of unfiltered air.

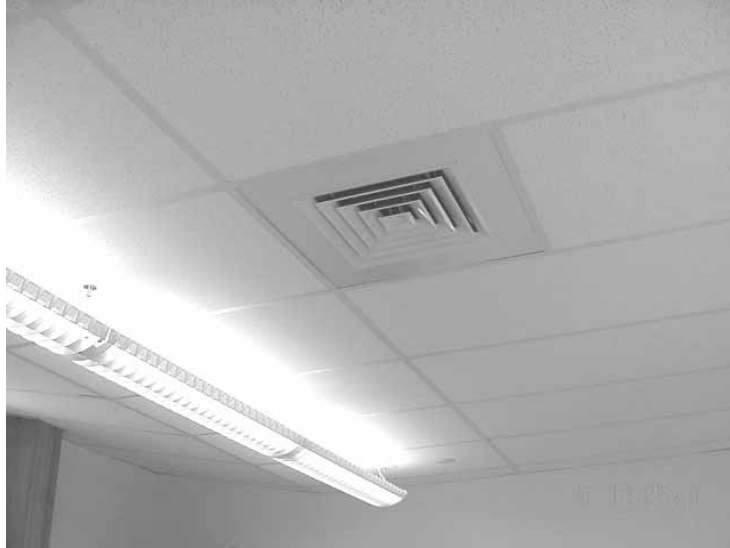
Picture 3

mentioned, mechanical ventilation is provided by AHUs, four of which are located on the roof, the other two are located in a mechanical room on the ground floor. Fresh air is distributed via ceiling-mounted air diffusers and ducted back to AHUs via ceiling or wall-mounted return vents (Pictures 2 to 4). It is important to note that the location of some exhaust vents can limit exhaust efficiency. In several classrooms, exhaust vents are located above hallway doors (Picture 4). When classroom doors are open, exhaust vents will tend to draw air from both the hallway and the classroom reducing the effectiveness of the exhaust vent to remove common environmental pollutants.

Ducted Supply Diffuser

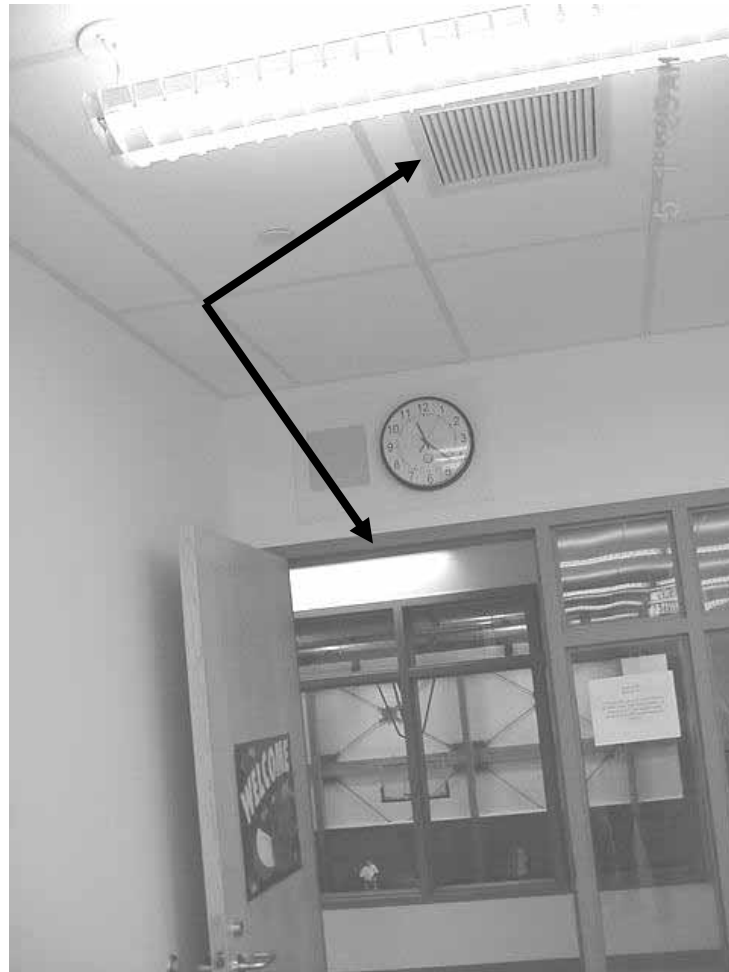
Picture 4

To maximize air exchange, the BEHA recommends that both supply and exhaust ventilation operate continuously during periods of school occupancy. In order to have proper ventilation with a mechanical supply and exhaust system, the systems must be balanced to provide an adequate amount of fresh air to the interior of a room while removing stale air from the room. It is recommended that HVAC systems be re-balanced every five years to ensure adequate air systems function (SMACNA, 1994). Mr. Johnson stated that the system was balanced over the summer of 2004 prior to occupation.

Return Vent, Note Proximity to Open Classroom/Hallway Door

5. Consider having the ventilation system balanced by an HVAC engineer every five years (SMACNA, 1994).
6. Ensure classroom doors are closed during periods of school occupancy to maximize exhaust ventilation.

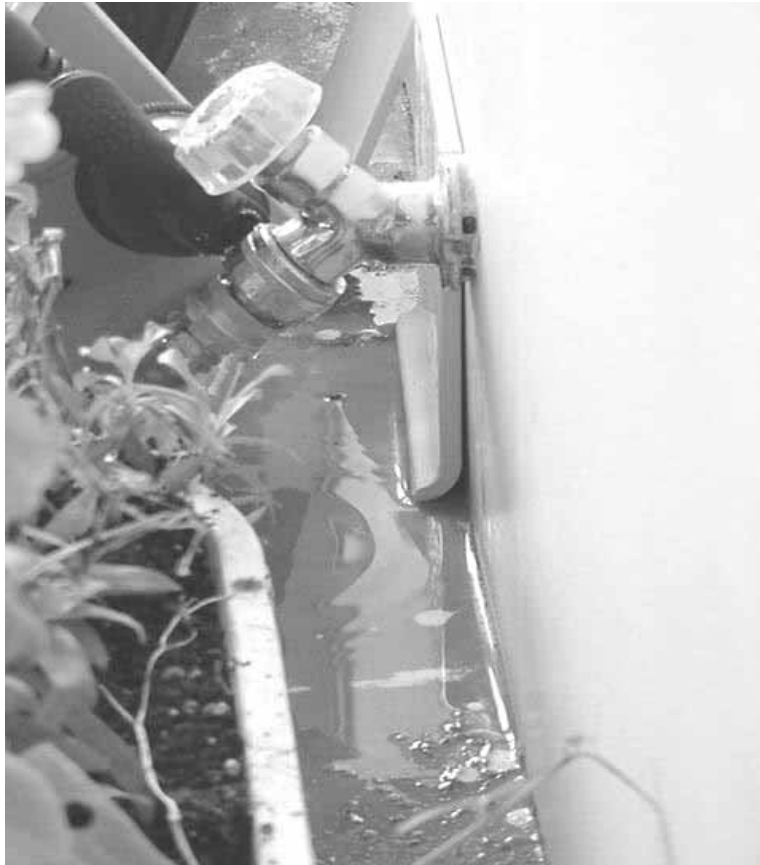
Picture 5

Several classrooms had a number of plants. Moistened plant soil and drip pans can be a source of mold growth. Plants are also a source of pollen. An atrium is located in the main hallway. This atrium, which is designed to serve as an indoor garden, has floor drains and a spigot/hose. During the assessment, the spigot/hose was observed to be leaking, and water was pooling against the wall in this area (Picture 5). BEHA staff conducted moisture measurements of the gypsum wallboard (GW) and found it to be saturated. Repeated water damage to porous building materials (e.g., GW, ceiling tiles, and carpet) can result in microbial growth. The US Environmental Protection Agency (US EPA) and the American Conference of Governmental Industrial Hygienists (ACGIH) recommend that porous materials be dried with fans and heating within 24 to 48 hours of becoming wet (US EPA, 2001; ACGIH, 1989). If porous materials are not dried within this time frame, mold growth may occur. BEHA staff recommended to Mr. Johnson that this GW be dried or replaced. Mr. Johnson stated that the GW would be replaced and ceramic tiles would be installed in this area to prevent further wetting.

Water Pooling Against Gypsum Wallboard in Atrium Area

9. Continue with plans to install ceramic tiles in the atrium to prevent wetting of GW.
10. Ensure all plants are equipped with drip pans. Examine drip pans periodically for mold growth and disinfect with an appropriate antimicrobial where necessary.

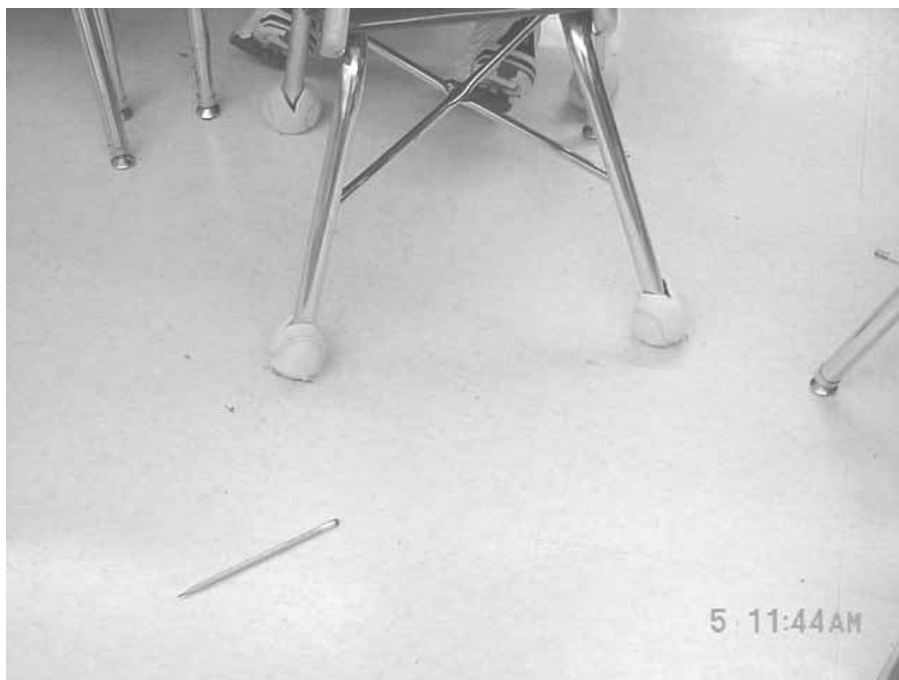
Picture 6

In an effort to reduce noise from sliding chairs, tennis balls had been sliced open and placed on chair legs (Picture 6). Tennis balls are made of a number of materials that are a source of respiratory irritants. Constant wearing of tennis balls can produce fibers and cause TVOCs to off-gas. Tennis balls are made with a natural rubber latex bladder, which becomes abraded when used as a chair leg pad. Use of tennis balls in this manner may introduce latex dust into the school environment. Some individuals are highly allergic to latex (e.g., spina bifida patients) (SBAA, 2001). It is recommended that the use of materials containing latex be limited in buildings to reduce the likelihood of symptoms in sensitive individuals (NIOSH, 1997). A question and answer sheet concerning latex allergy is attached as [Appendix B](#) (NIOSH, 1998).

Tennis Balls on Chair Legs
